FIRES IN THATCHED BUILDINGS

Updated to include the 2010/2011 heating season, 61 fires in total

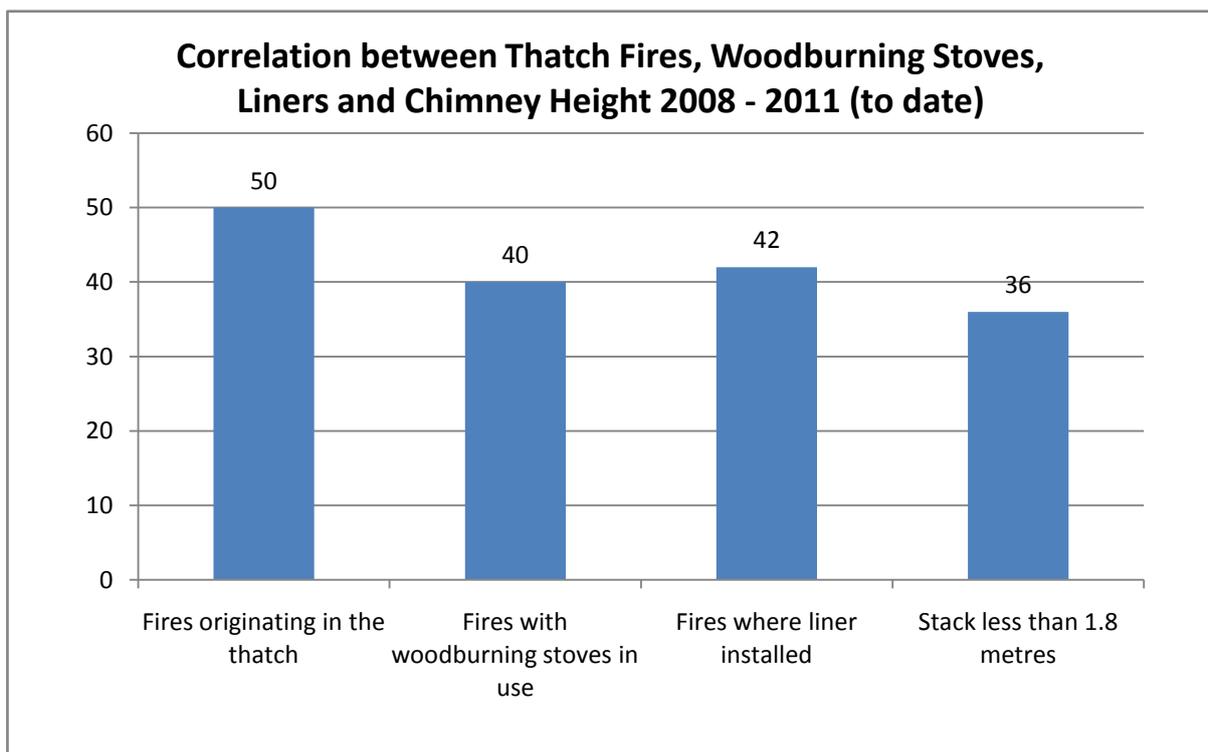
Figure A

Flue liners were present in all 40 cases involving wood burning stoves (see figure A) and one open fire was connected to a liner, which was to be expected since in recent times a liner has almost always been fitted along with the stove. In 36 of those 40 cases, the chimney was less than 1.8 metres high, the minimum height specified in the Building Regulations 2000 for combustible roof coverings, including thatch.

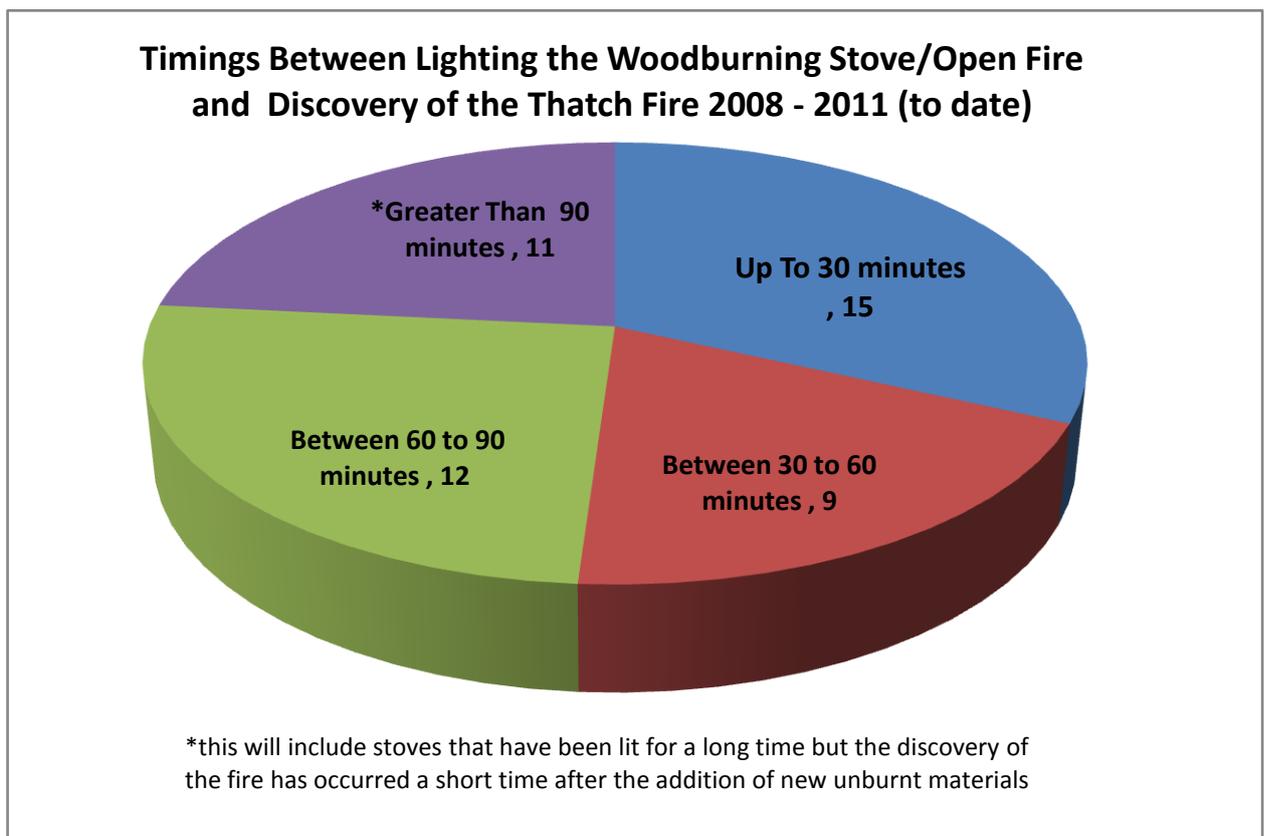
Figure B

The time between the lighting of the stove or fire and discovery of the fire was also examined and out of the 40 fires, 15 occurred within 30 minutes of lighting, 9 between 30 and 60 minutes and 12 between 60 and 90 minutes (see figure B). **Thus a total of 36 of the 40 fires occurred within 90 minutes of lighting, a very striking statistic.** Moreover, in a number of other instances, fuel had been added to an existing fire within 60 minutes of discovery. A further factor was that in 5 cases a chimney fire was reported.

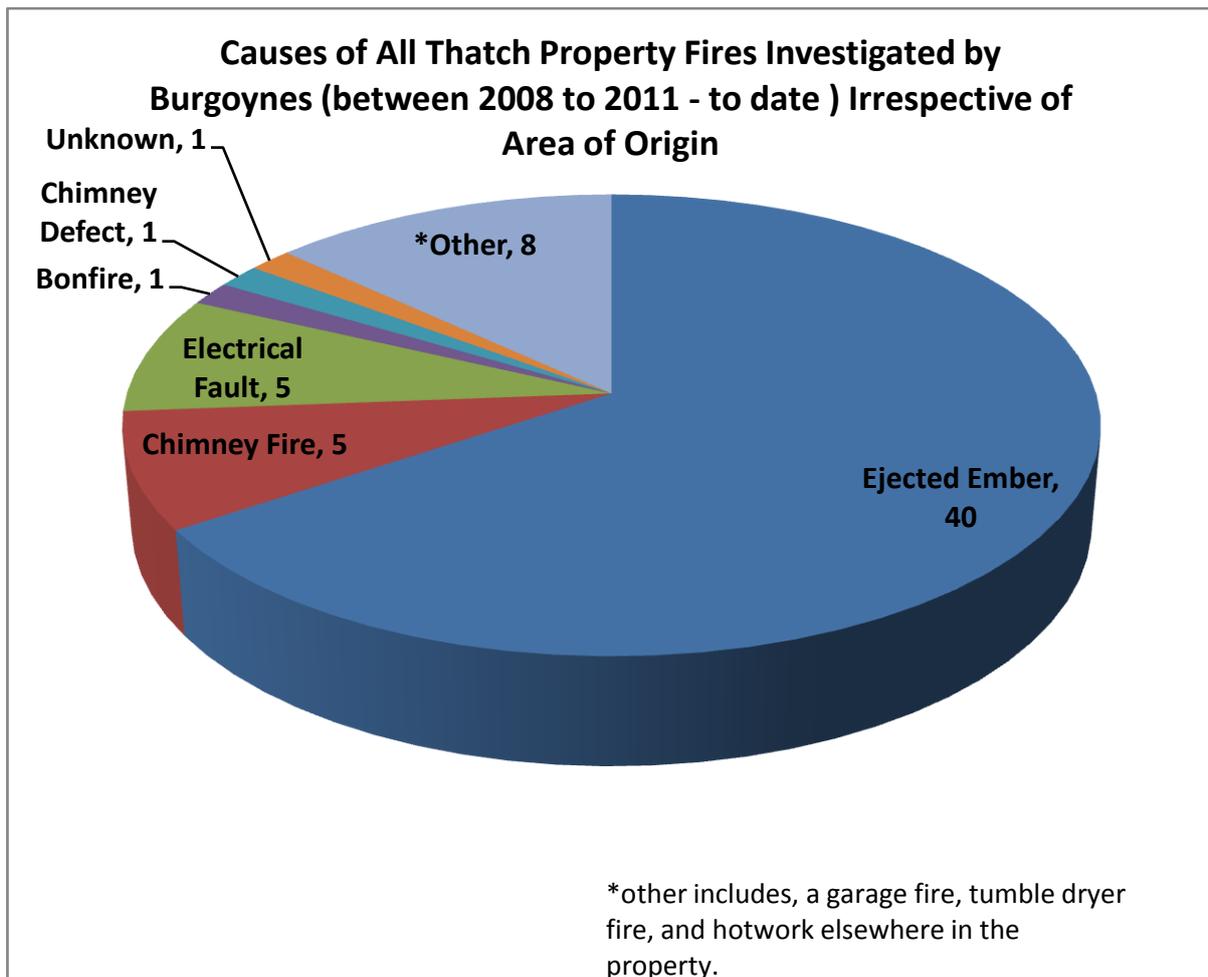
Figure C

Looking at all of the 61 investigations (see figure C), by far the most common cause identified by Burgoyne's was an ejected ember (40), with the next most common being chimney fire (5) and electrical (5). A chimney defect was only identified in one case.
